**NATIONAL TRANSPORTATION SAFETY BOARD
WASHINGTON, D.C. 20594
AIRCRAFT ACCIDENT REPORT**

UNCONTROLLED COLLISION WITH TERRAIN

**AMERICAN INTERNATIONAL AIRWAYS FLIGHT 808
DOUGLAS DC-8-61, N814CK
U.S. NAVAL AIR STATION
GUANTANAMO BAY, CUBA
AUGUST 18, 1993**

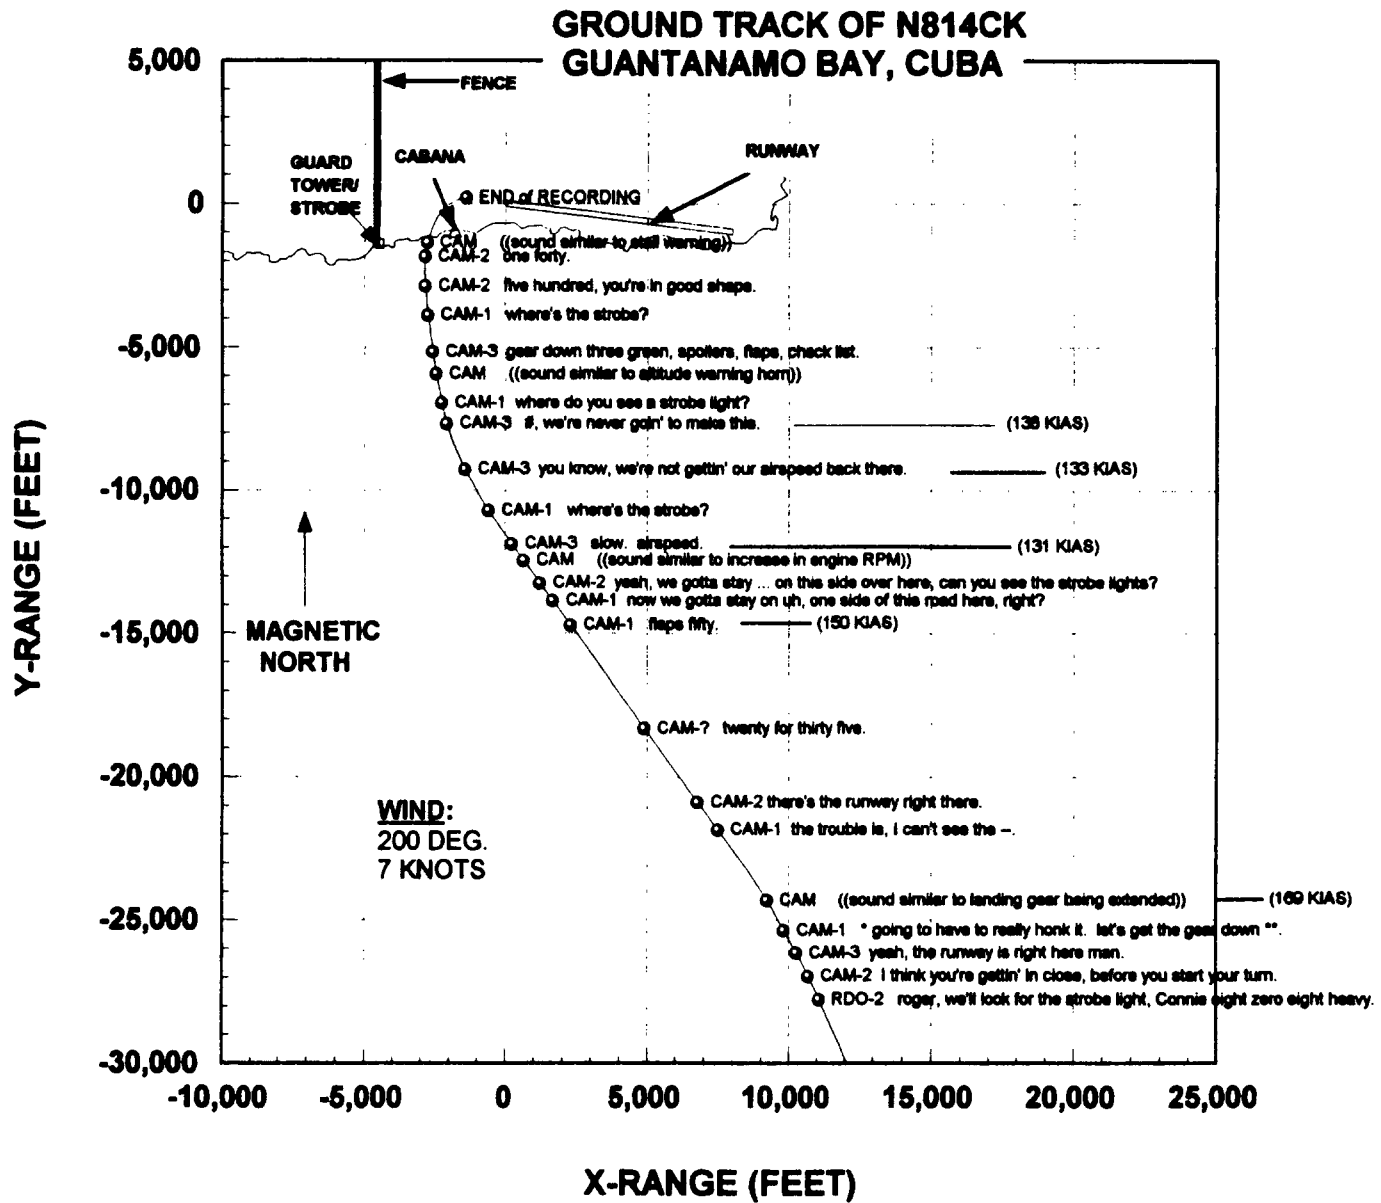
Figure 1.--Ground track of flight 808.

The airplane struck the level terrain approximately 1400 feet west of the approach end of runway 10. The accident occurred during the hours of daylight at 19 degrees 54 minutes North latitude; and 75 degrees 13 minutes West Longitude. Figure 1 depicts the ground track of flight 808 derived from flight data recorder (FDR) information.

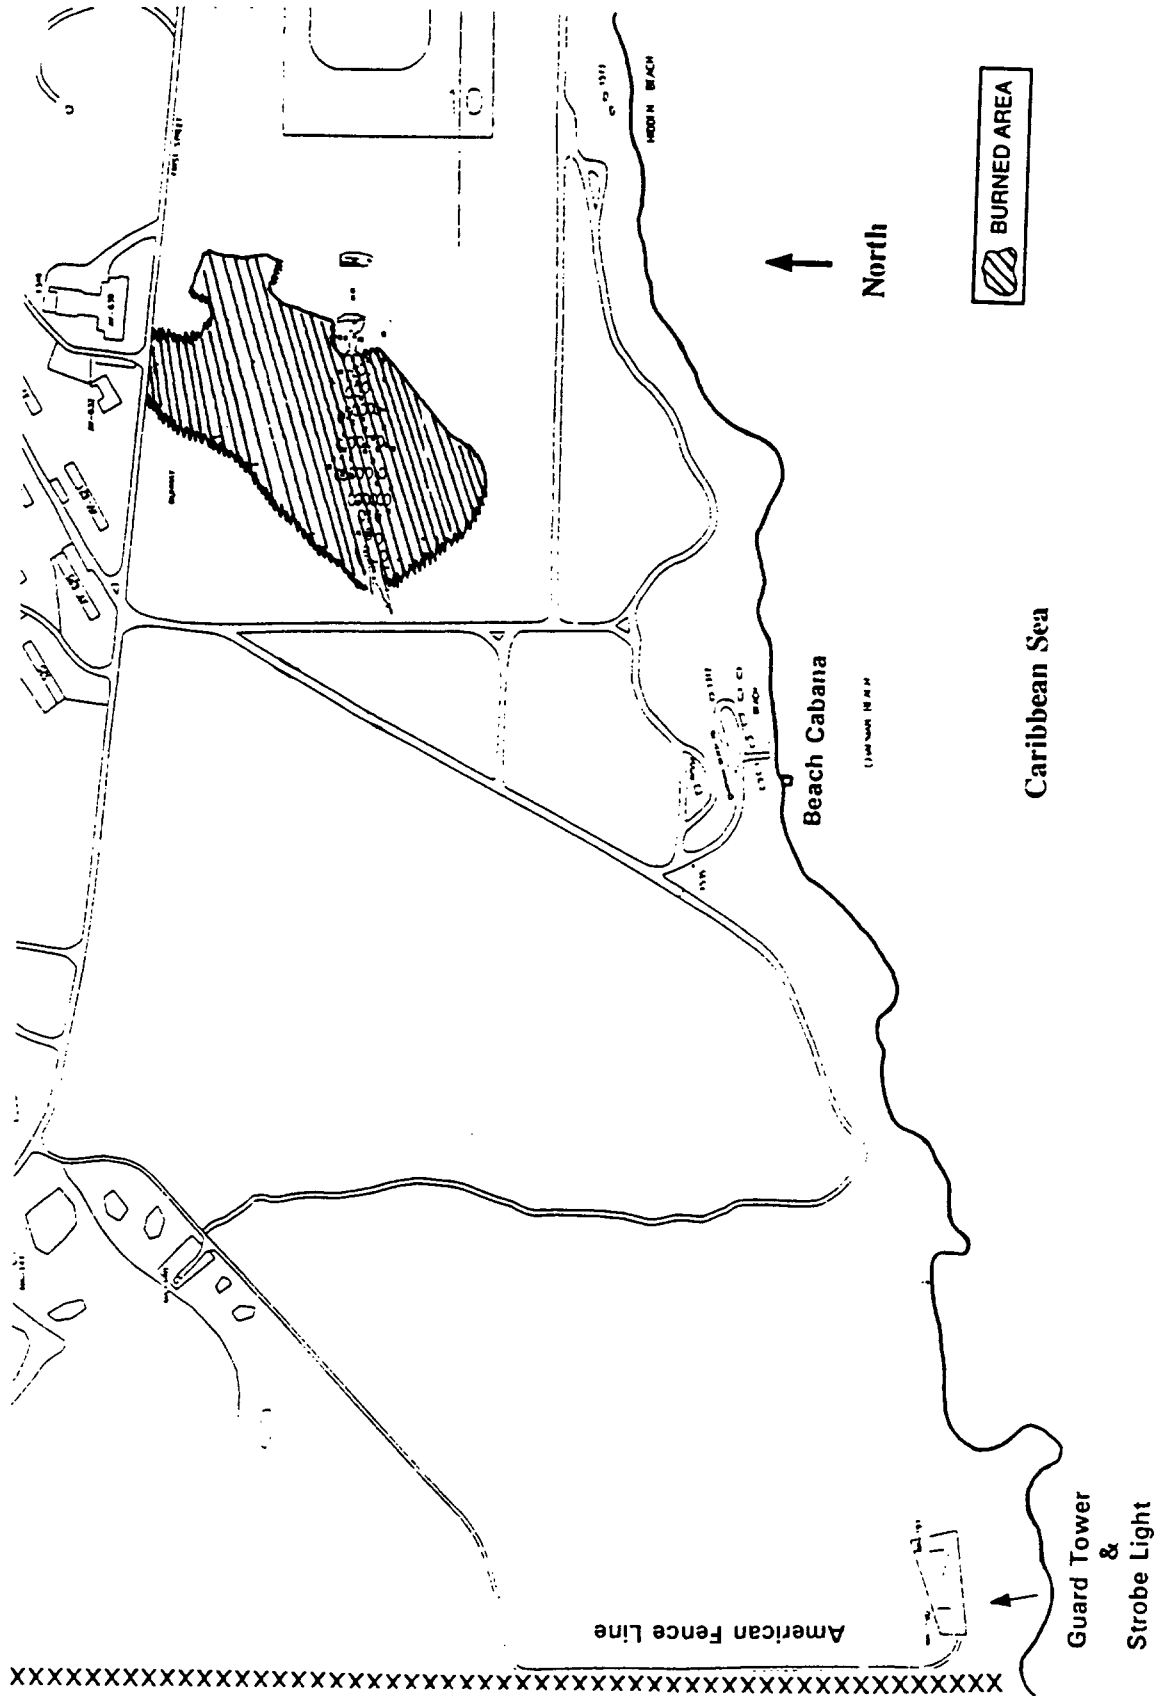
Figure 2.--Location of airplane wreckage.

The airplane initially struck the ground 200 feet north of the extended runway centerline and 1,400 feet west of the runway 10 threshold (see figure 2). The wreckage debris was oriented on a magnetic heading of approximately 100 degrees and extended for a distance of about 1,000 feet from the initial impact point. The debris found at the farthest point from the runway consisted primarily of right wing structure and skin, as well as parts from the Nos. 3 and 4 engines.

The initial impact mark was a thin, shallow trough that fanned outward to about 25 feet wide and extended 150 feet in the direction of flight. The right wing tip, found 200 feet north of the first impact point, exhibited compression damage and scratch marks that were consistent with the airplane in a roll attitude of 51 degrees at the point of initial ground impact.

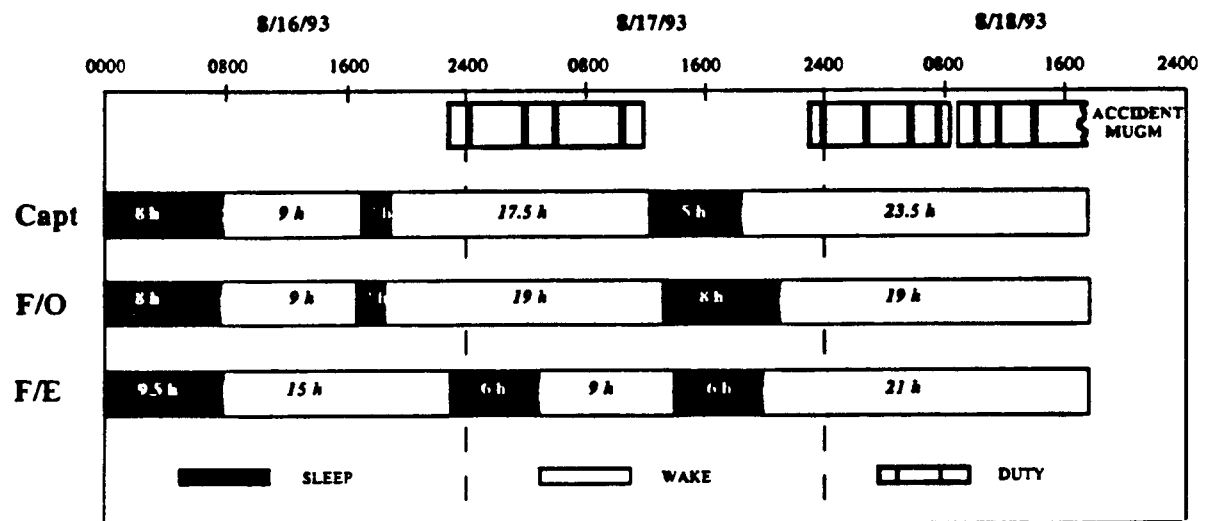
Figure 3.--Flightcrew sleep/wake histories.

The researchers found in their study of the crewmembers' sleep/wake periods that in the 28.5 hour period prior to the accident, the cumulative totals for sleep and wakefulness for the captain, first officer, and flight engineer were: 23.5 hours awake with 5 hours of sleep, 19 hours awake with 8 hours of sleep, and 21 hours awake with 6 hours of sleep, respectively. (See figures 3 and 4).
